FACILITY STATUS CHANGE FORM

Date Submitted: Feb 14, 2013 Originator: David Warren Phone: 539-6040	Area: 100-N Facility ID: 105-NE Fission Products Trap Action Memorandum: 100-N Ancillary Facilities	Control #: D4-100N-0047
---	---	-----------------------------------

D4 Project Facility Completion Form

This document provides information regarding the history, characterization, and final status at the completion of deactivation, decontamination, decommissioning, and demolition activities of the 105-NE Fission Products Trap, formerly located at the 100-N Area.

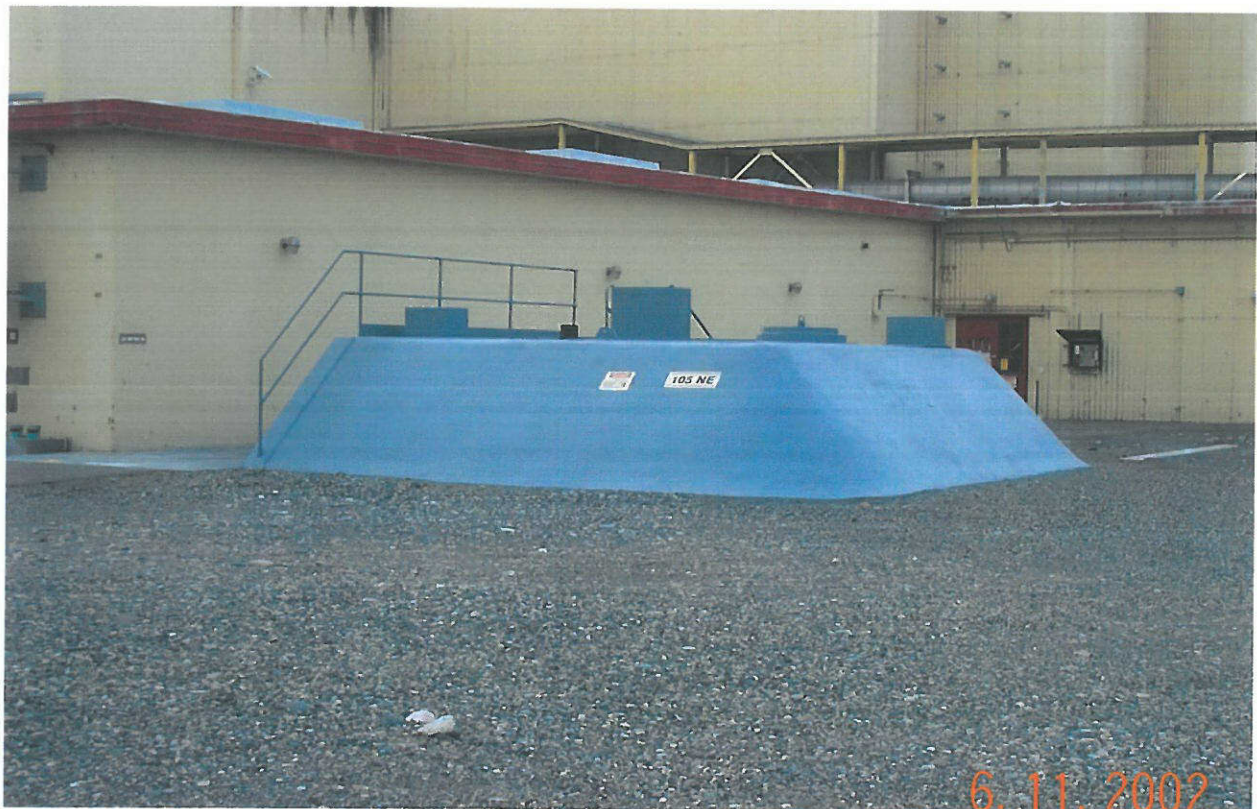
105-NE Pre-Demolition

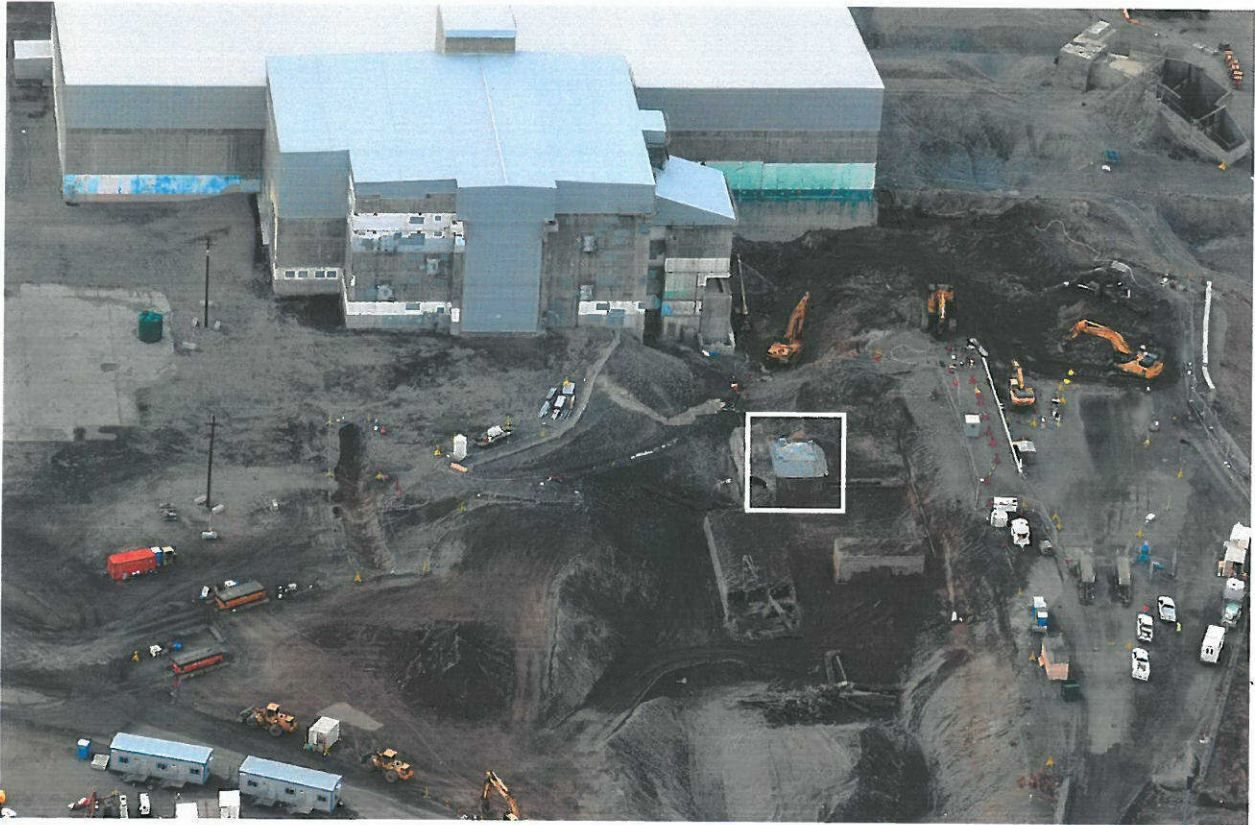
105-NE Pre-Demolition (December 2011)

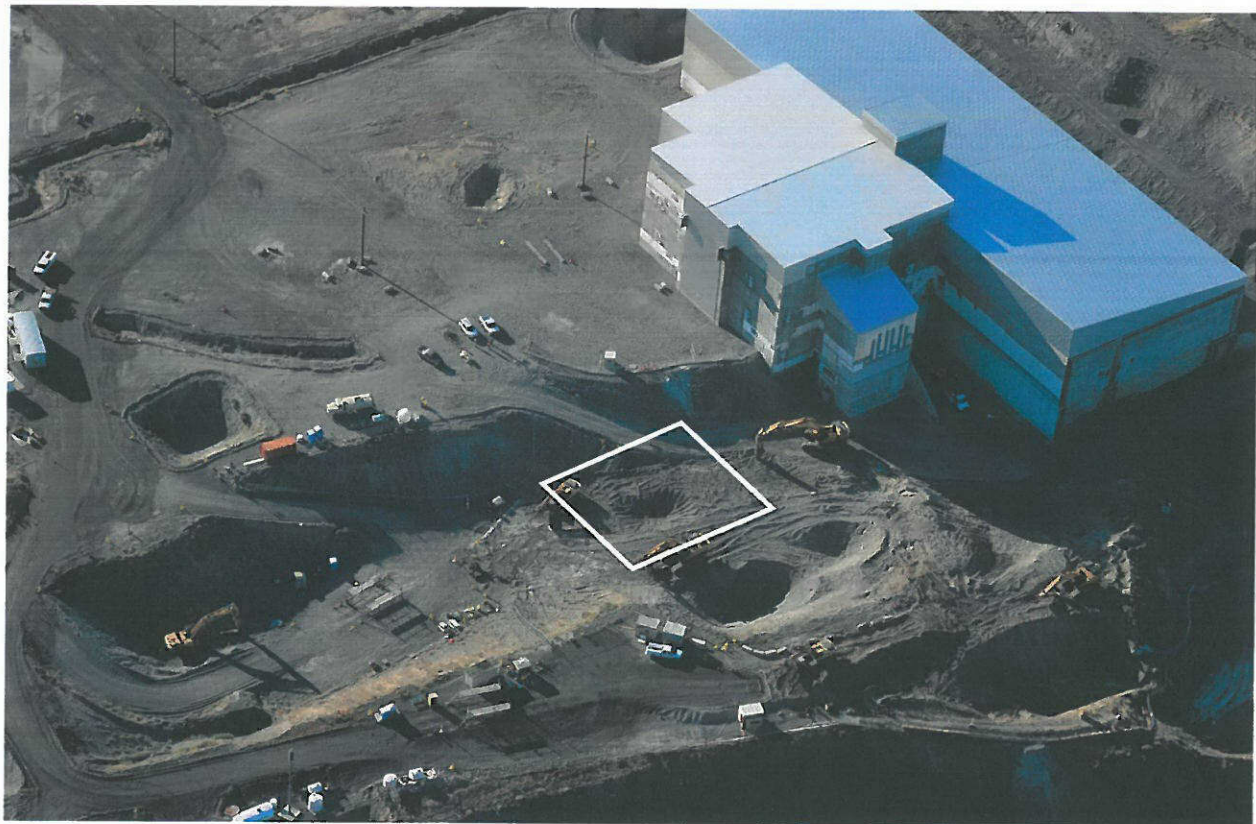
105-NE Post-Demolition (September 2012)

The 105-NE Fission Products Trap was entirely demolished by April of 2012. The resulting debris was shipped to the ERDF, where it was disposed.

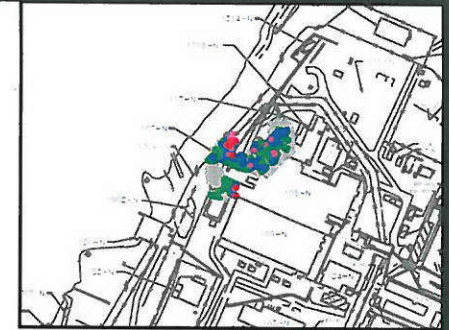
100N D4 1303-N Work Zones GPERS Radiological Survey Gamma Track Map

Bkg Location
625 meter SE

Coverage File: N,NN349, A,B,C
Number of Data Pnts: 8717
Type of Survey: Gamma
Max GCPM: 680,272
Avg Bkg CPM: 1327
Survey Date: 12/14/2012
Area Surveyed: 2250 m²
Project File: ESRFRM120150G
Pdf File: ESRFRM120150GC

Residual radiological contamination was detected during post-demolition GPERS surveys performed at the footprint of the 105-NE Fission Products Trap. This contamination is being deferred to the 100-N-66 WIDS site, and accordingly, closeout of the 105-NE Fission Products Trap footprint will be addressed during closeout of the 100-N-66 WIDS site. The pertinent GPERS surveys are provided in Attachment 3.

Post-demolition GPERS surveys identified an elevated level of radiological contamination within, and adjacent to, the facility footprint (ESR-FRM-12-0150BC, ESR-FRM-12-0150GC, GPERS Beta Map Location Overlay [attached to this form], and GPERS Gamma Map Location Overlay [attached to this form]).
